## **USDA Hurricane Mitch Recovery Program**

*Damaged Rural Watersheds Rehabilitated through Strengthened Local Capacity.*

### **C. Country Program Description--Guatemala**

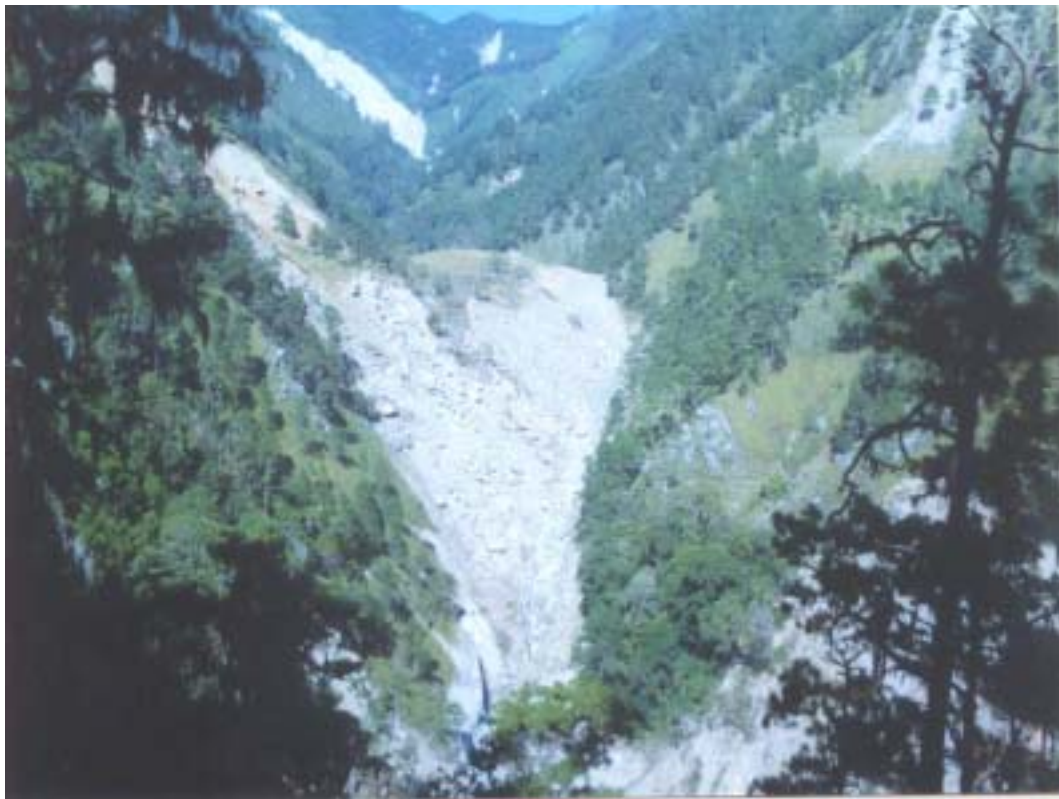
**Figure 3. Photo of a large high elevation landslide in the *Sierra de las Minas* range. Landslides are sources of sediment, which contribute to ongoing damage in lower elevation agricultural zones after rainstorms.**

These hydrological services were significantly disrupted by Hurricane Mitch in October of 1998. In Guatemala, as elsewhere, the relatively poor state of the natural environment, particularly in the uplands, contributed greatly to the devastation in the lowlands and valleys. Along the southern flank of the Sierra, made vulnerable by annual wildfires and overgrazing, the damage was particularly severe. In addition to crop losses and the loss of agricultural land along stream courses, Mitch caused landslides (figure 3), created newly eroded surfaces, and degraded agricultural lands.

Numerous landslides are the source of extremely high sediment loads that continue to cause damage to infrastructure and agricultural activities during even normal rainfall events. Increasingly it is recognized within Guatemala that lowland agriculture and infrastructure depend upon the quality of watershed management in the uplands.

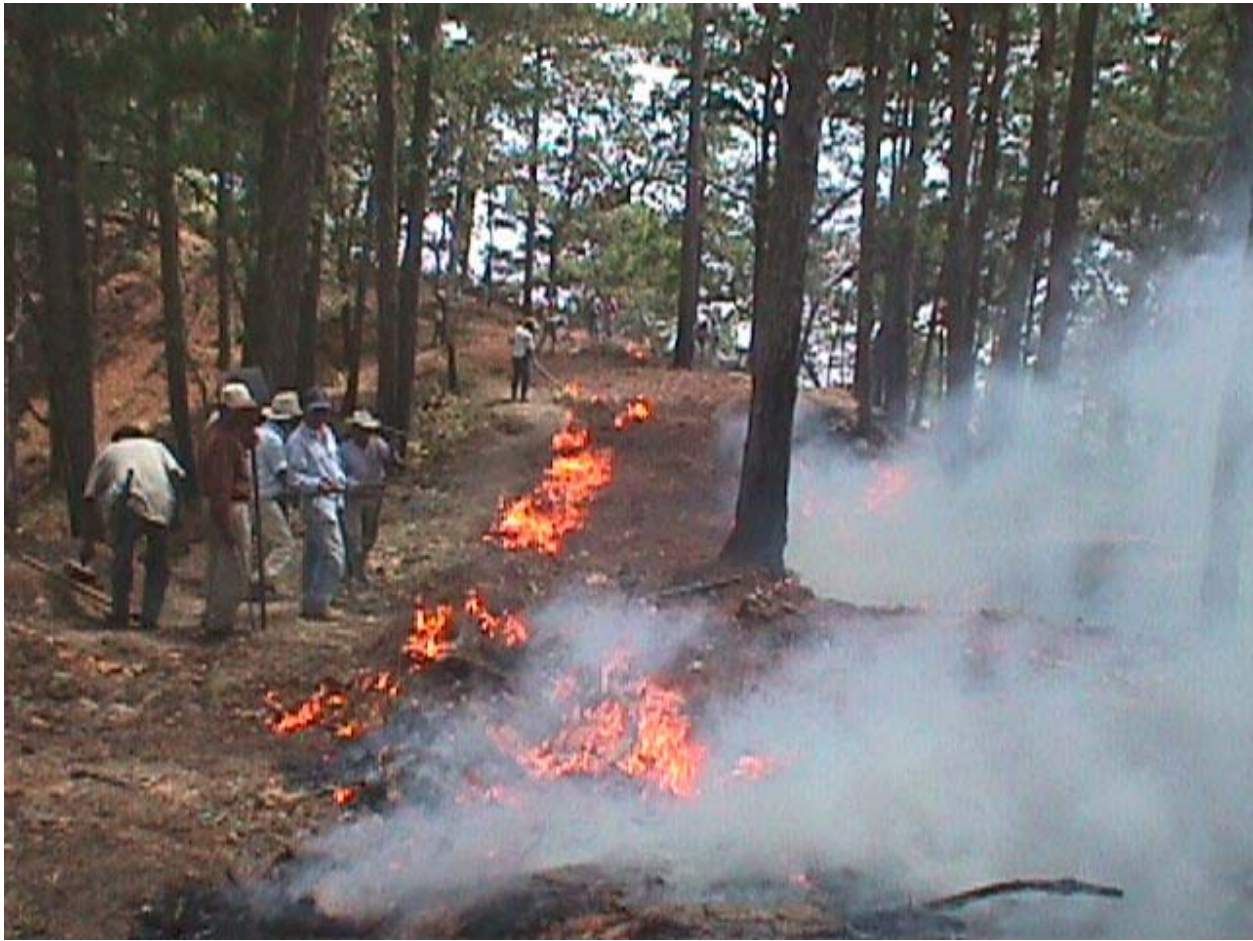
**Figure 5. Training in the use of fire as a tool to reduce vulnerability to uncontrolled forest fires**

Accomplishments are summarized in Table 1 on the next page. Figure 5 on the following page shows a hands-on training session where fire is used as a tool to reduce fuel loading in a forested zone of SMBR. Such management fires reduce ecosystem vulnerability to devastating wildfires during the dry season.

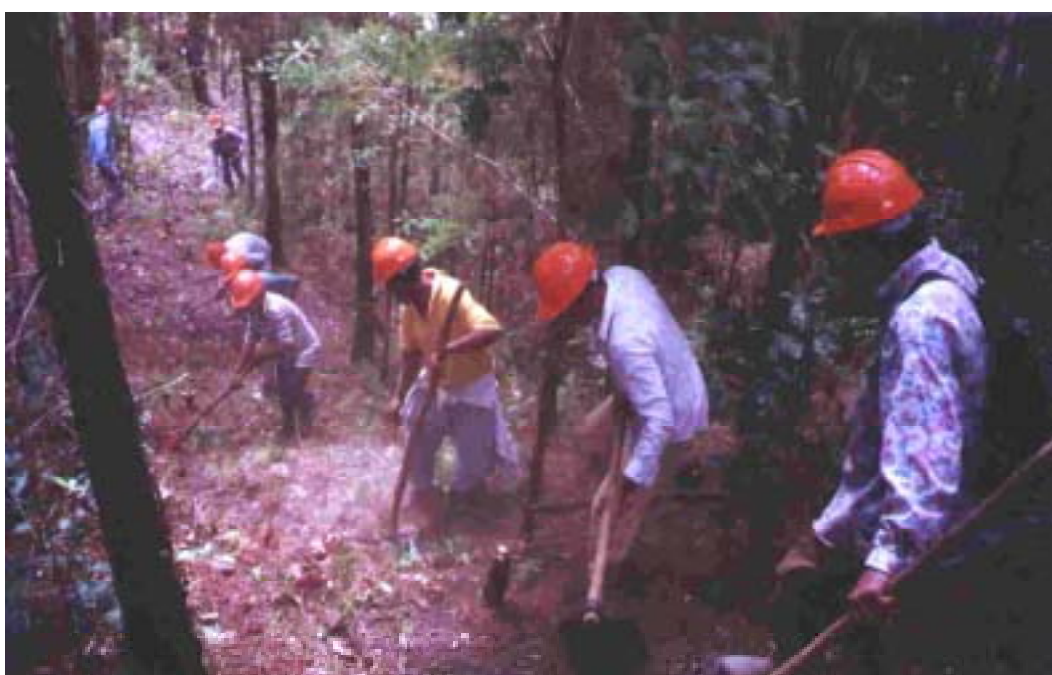
## **Brechas Corta Fuegos**

**Figure 6. Construction of firebreak using hand tools**

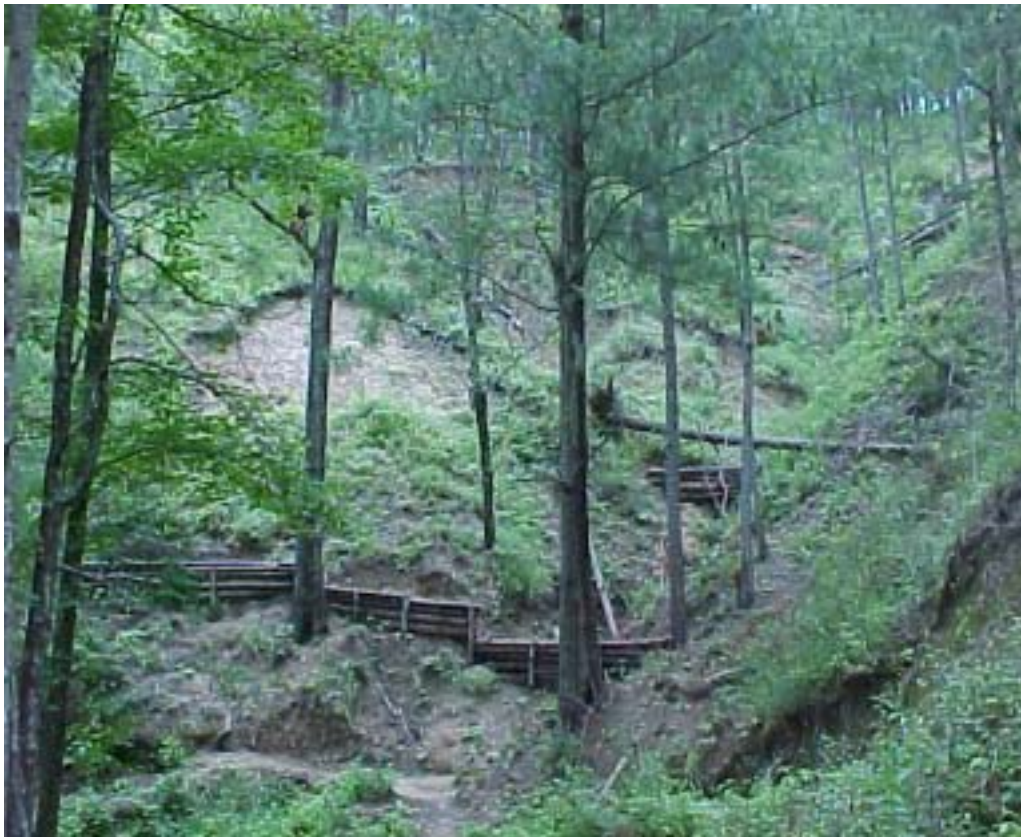
Figure 7 below is an example of a several small landslides stabilized in the SMBR. Note that the slide is situated in a draw which will more rapidly lead to sediment entering watercourses during rainfall events if left untreated.

**Figure 7. Example of a landslide treated through construction of retaining walls using local materials**

- **Retention of sediment**—At the base of landslides retaining walls were constructed of local materials to prevent movement of sediment from the base of the slide. This was either constructed of rock or wooden stockades which were available in the immediate vicinity of the landslide (figure 7).
- **Establishing drainage**--Cut-off drains were established above each landslide so that during rain storms run-off moving down slope would be minimized across each landslide. This had the effect of reducing the propensity of further movement.
- **Gabions**--Stone-filled baskets to hold back soil and debris.
- **Revegetation**--Seeding and planting of portions of the slides with suitable plants was undertaken to stabilize areas by root development holding soil and through the

- **Maintenance**--Maintenance is important to repair minor breaches in retaining walls and reseed bare areas.

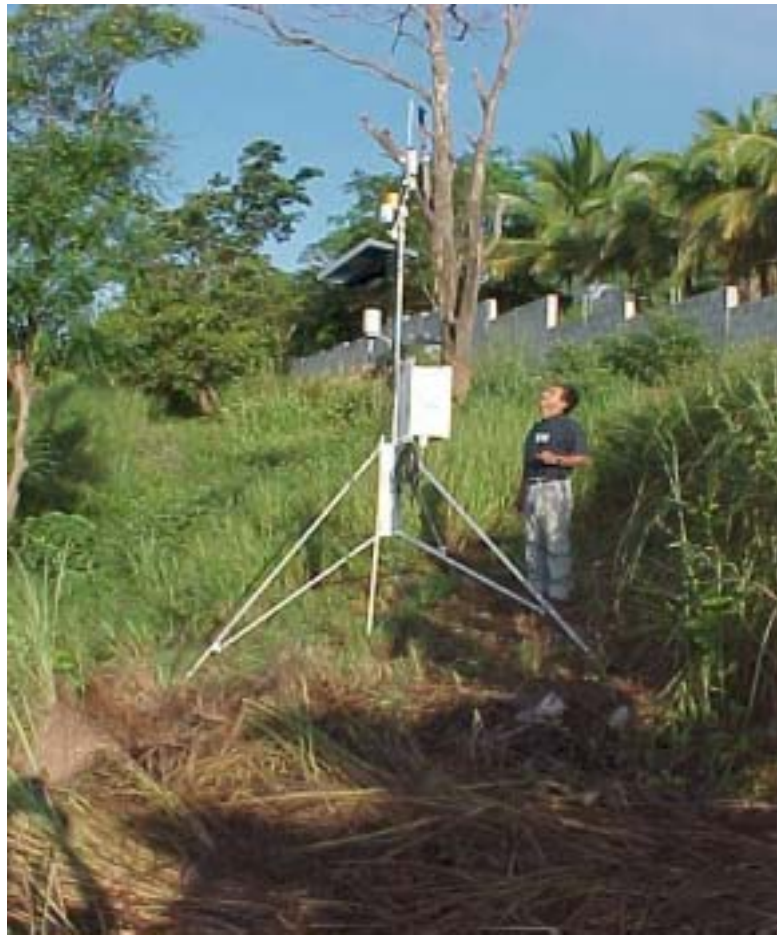
**New technology**—The weather stations selected were those recommended for use by the U.S. Forest Service and include automated data recording and satellite links by radio. It was necessary to send Forest Service technical specialists to Guatemala to assemble the stations from their component parts and provide training to FDN staff in the use and maintenance of the stations. The equipment was purchased from Campbell Scientific in the US and was model CRX10 (figure 8).

**Figure 8. Campbell Scientific weather station installed at SMBR.**

An important component of USDA's assistance was the financing and technical training associated with the installation of modern field weather stations. Three stations were installed resulting in an important contribution to Guatemala's weather monitoring capabilities, since the SMBR is one of the most important sources of water for southeastern Guatemala. Collecting weather data is allowing improved ability to document hydrological function and will enhance the ability of Guatemalan authorities to link rainfall events with flooding potential thus reducing vulnerability in local communities lower in the watershed. In addition, weather monitoring is very important in fire management, since rainfall, humidity, wind speed, etc. are all very important in predicting fire hazard and are useful in determining when conditions are optimum for prescribed burning.
